HOUSTON LAKE DAM

PLATTE COUNTY, MISSOURI

MO 10002

PHASE 1 INSPECTION REPORT NATIONAL DAM SAFETY PROGRAM.

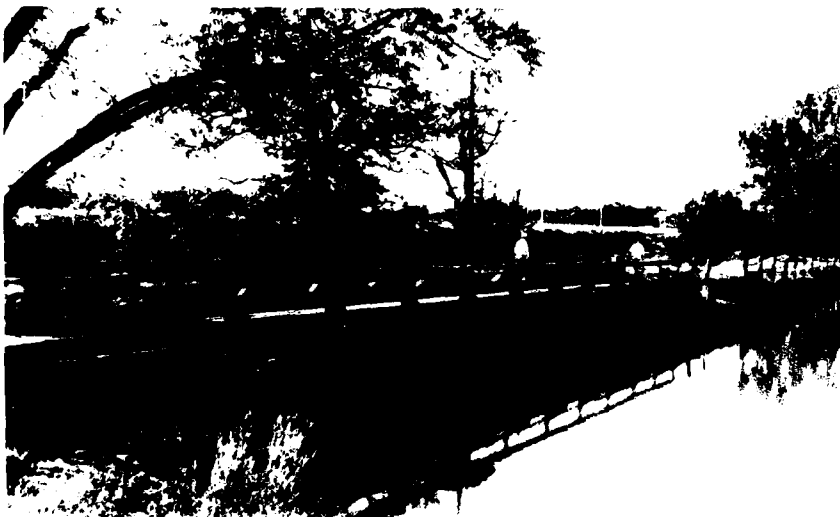
PHOTO NO. 3
SPILLWAY INLET
AND UPSTREAM SLOPE
FROM LEFT ABUTMENT

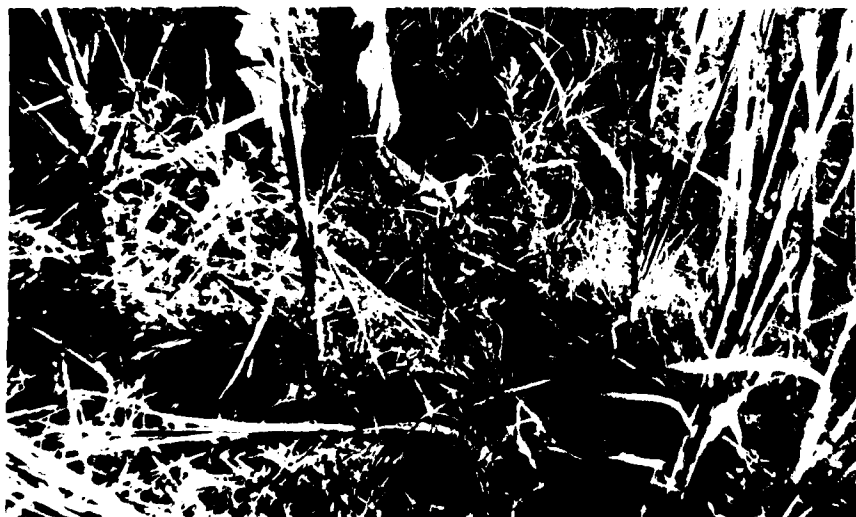
PHOTO NO. 7
FREE WATER IN
CATTAILS AT DOWN-
STREAM TOE STA. 3+50
